Why are OSPF Neighbors Stuck in Exstart/Exchange State?

Document ID: 13684

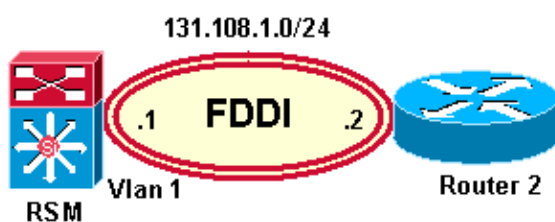
The above diagram shows a Fiber Distributed Data Interface (FDDI) port on a Cisco Catalyst 5000 with a Route Switch Module (RSM) connected to a FDDI interface on Router 2. The Virtual LAN (VLAN) on the RSM is a virtual Ethernet interface with a MTU of 1500, and the FDDI interface on Router 2 has a MTU of 4500. When a packet is received on the FDDI port of the switch, it goes to the backplane and the FDDI to Ethernet conversion/fragmentation happens within the switch itself. This is a valid setup, but with MTU mismatch detection feature, OSPF adjacency is not formed inbetween the router and the RSM. Since FDDI and Ethernet MTU are different, this **ip ospf mtu-ignore** command is useful on the VLAN interface of the RSM so that OSPF stops detecting MTU mismatch and forms the adjacency.

In Cisco IOS Software 12.01(3), the **ip ospf mtu-ignore** interface configuration command was also introduced to turn off the MTU mismatch detection; however, this is only needed in rare instances, as shown in this diagram:
